ROPE GUIDES

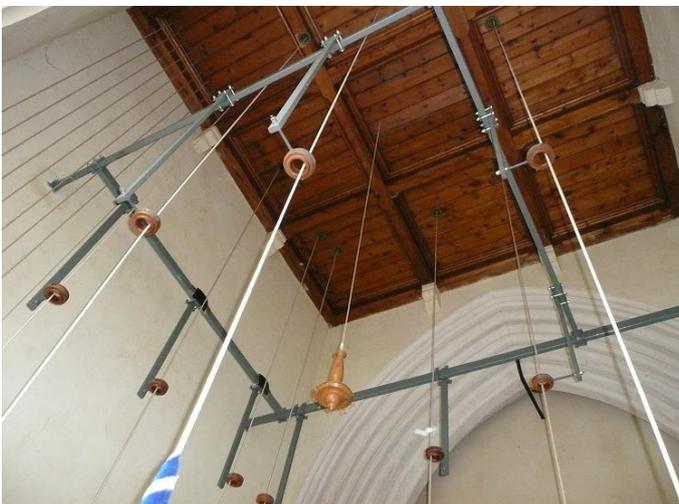
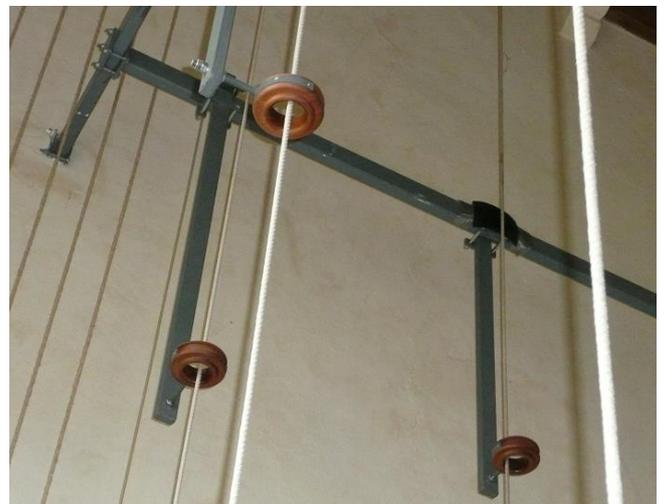
The main frame is out of the sight line from the nave and the extensions for each rope guide are adjusted to meet mutual requirements of sight line and bell control.

Practical experience shows that by introducing a rope guide around 15ft 9in above the floor, rope movement is greatly improved, with the sideways looping in the intermediate chamber reduced. If the guide at this level interrupts the view of the St Faith window from the nave, a suitable guide framework can be designed to reduce this intrusion to a minimum and below is a photo of such a format adopted in Felmingham, Norfolk.
